# Capturing slope data

DK Llewelyn explains how photogrammetric mapping can be used for pit slope angle optimisation

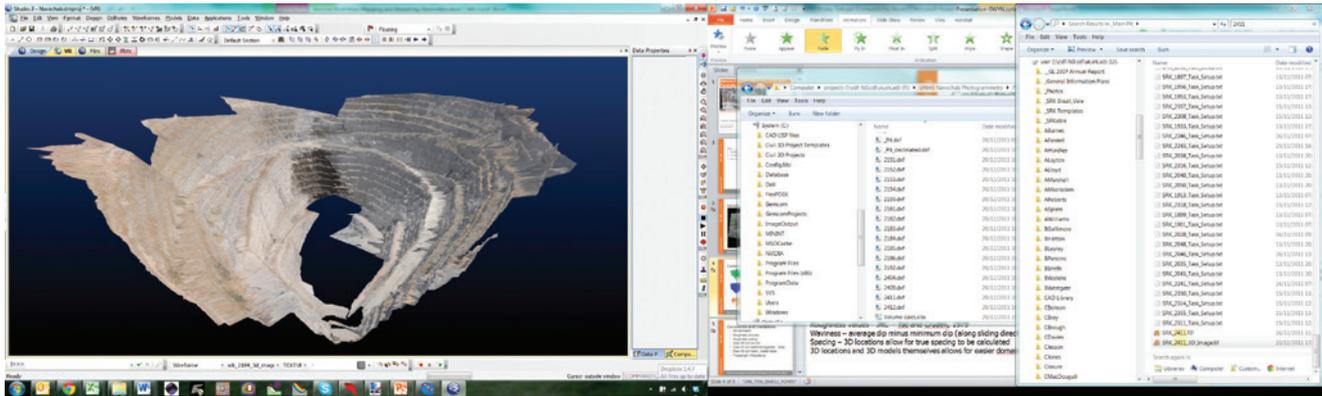
Figure 1: 3-D Mosaic image showing the hanging-wall and footwall

Photogrammetric mapping requires the cameras to be at a certain distance from the face so that the entire height of the face/bench can be captured in the 3-D image. Photogrammetric mapping was applied to both the hanging-wall and footwall (Figure 1).

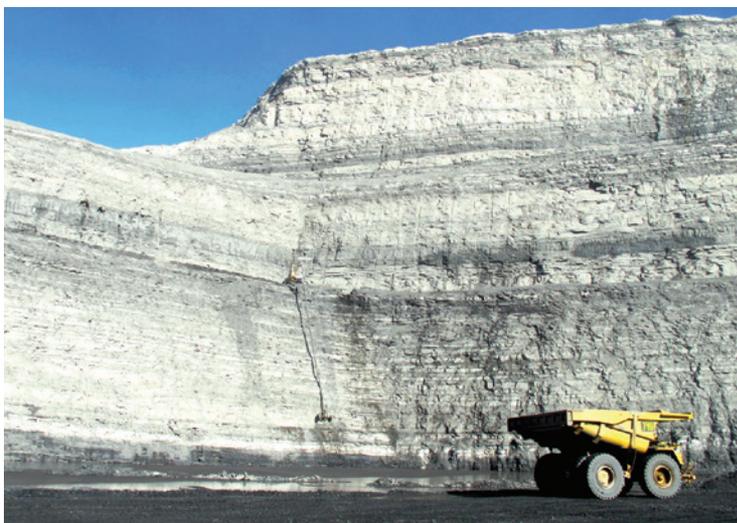
Excellent excavated wall conditions

**Figure 2:** Overlapping 3-D images were stitched together to form mosaics, allowing for mapping of larger (full bench and multi-bench scale) features that spanned across numerous models.

The hanging-wall of the gold mine is a quartzite material and was accessible along each of the three ramps: north, central and south areas. The analysis focused on domaining the hanging-wall to determine any structural changes along the pit strike. Major Joint Sets were chosen using DIPS (a Rocscience stereographic analysis program) according to the concentration of orientation poles on the stereonets and trace length of individual data points (Figure 2).

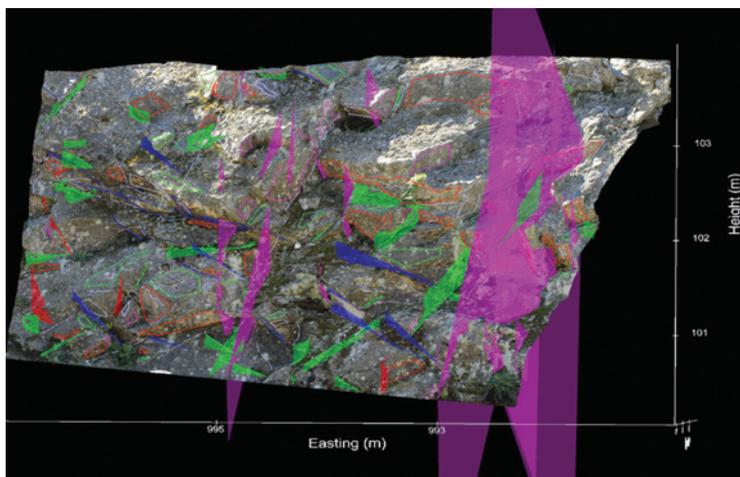
**Figure 3 (below):** Part of a single bench showing the mapped discontinuities. **Figure 4 (below right):** 2-D pit slope section analysed using Phase<sup>2</sup> software

the measurement of the joint roughness coefficient (JRC), trace length and spacing values for each structural set (Figure 3). A statistical analysis was carried out upon each discontinuity set to calculate average, minimum, maximum and standard deviation values of spacing, roughness and trace length for each set.
